MEMORANDUM

Reference: P₄ Production Southeast Idaho Mine-Specific Selenium Program (1010076.011601)

Subject: *Subtask 4d–Agronomic testing of unreclaimed, poorly reclaimed, and well reclaimed land of the Ballard Mine site investigation (SI)*

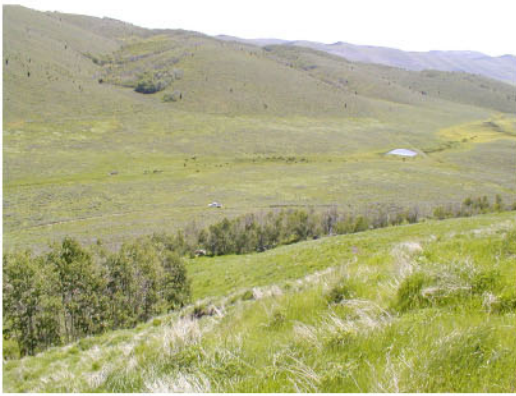
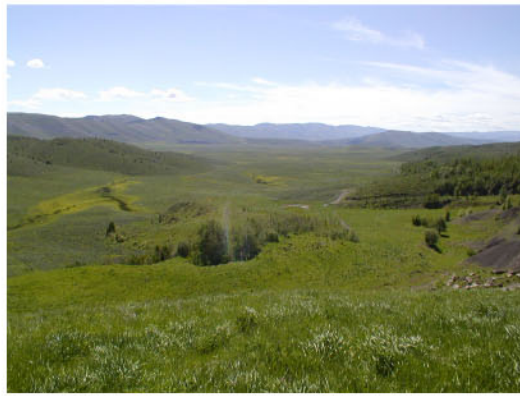
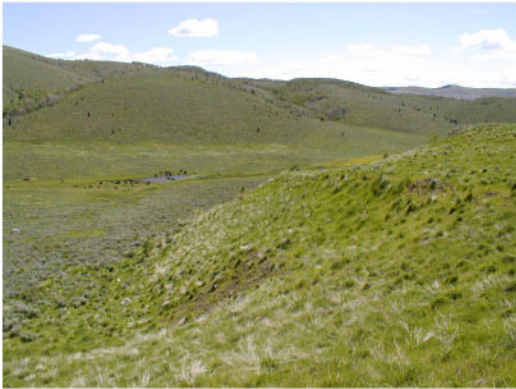
- MWD084: Located in the NE portion of Ballard Mine, N, NE, and E of MMP039. All areas of this waste rock dump appeared to be densely vegetated with various grasses and alfalfa (WR01). See Photos 1, 2, and 3.
- MMP039: Located in the NE portion of Ballard Mine near MWD084. The pit base, disturbed areas, and backfilled areas of the pit all seemed to have very little (none to very sparse) vegetation growth (UR01). Some trees were observed growing in some pit/backfill areas. The soil color was predominately black or light black and the soil appeared to consist of fine grains. See Photos 4, 5, and 6.

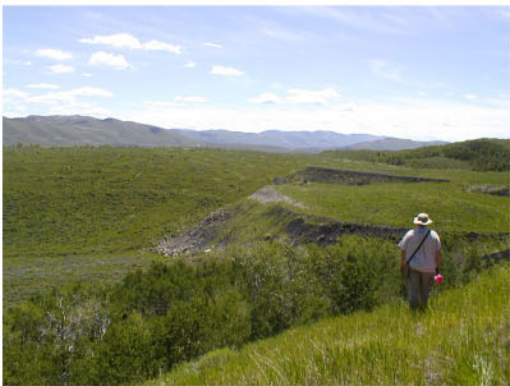
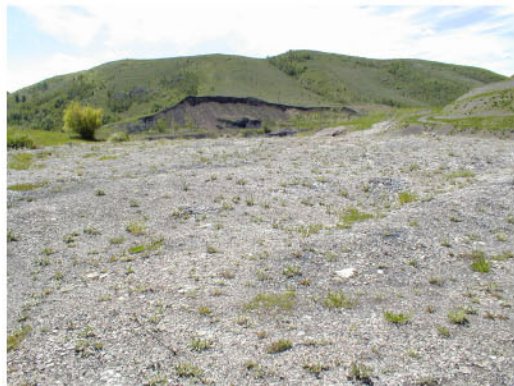
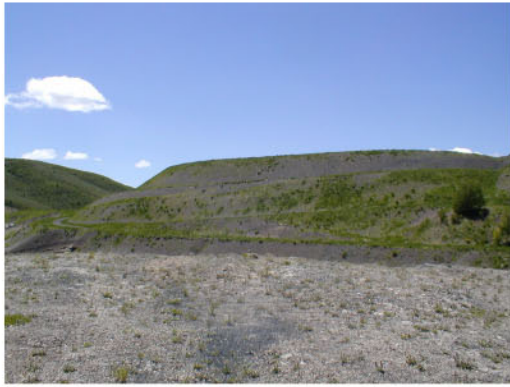
MWD082: Located in the E and SE portion of Ballard Mine. All of the MWD082 waste rock dump, except five localized areas, appear to be densely vegetated with grasses and alfalfa (WR02), especially the main portion of the waste rock dump to the E, SE, and S of the MMP037 pit. See Photos 7, 8, and 9.

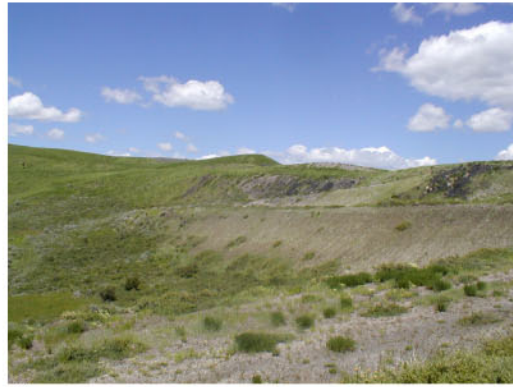
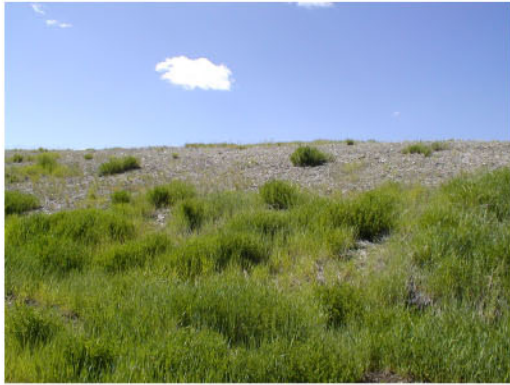
The first area of MWD082 that is not well reclaimed is a backfilled pit area/waste rock area that is located N of the MMP037 pit and E of the gravel road. This area appeared to be mostly a bare area with very little vegetation growth, some sparse plants present, but no grass or alfalfa was observed growing in this area (UR02). The UR02 area was a flat area on top of the waste rock dump and consisted of white, tan, and black shales (mostly lighter shales). Note, the side-hills and slopes of this area facing N and E appeared to be fairly well vegetated (densely vegetated) with grasses and alfalfa. See Photo 10 and 11.

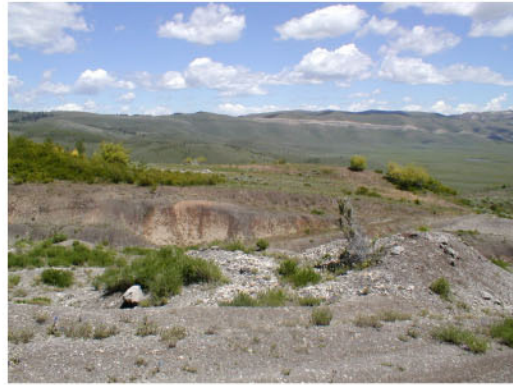
12

The second area of MWD082 that is not well reclaimed is the portion of the waste rock dump that is located immediately west of the MMP037 pit, and west of the gravel road, is fairly well vegetated (densely) except the E facing slope that is uphill (west) of the gravel road. This slope area has sparse to moderate vegetation consisting of grasses and alfalfa (PR01). The angle of this slope is steep and appears to consist mainly of tan shales. See Photo 12.

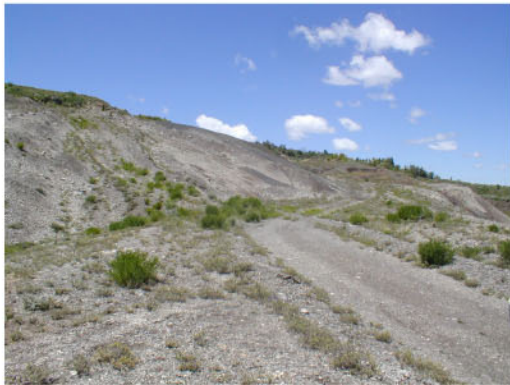
13

The third area of MWD082 that is not well reclaimed is located near the first gravel road split off at the SW corner of MMP037, south of the PR01 area. This area appears to have no vegetation to sparse vegetation growth consisting of grasses and alfalfa (UR03). See Photo 13.

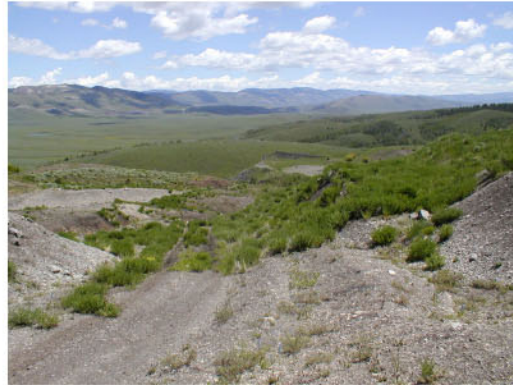
14

The fourth area of MWD082 that is not well reclaimed is located between PR01 and UR03 at the second gravel road split off at the SW corner of MMP037. This small area is located approximately 200 meters down the gravel road leading left at the second split in the gravel road. This area is a small area of black shales that appears to have no or very sparse vegetation growth (UR04). See Photo 14.

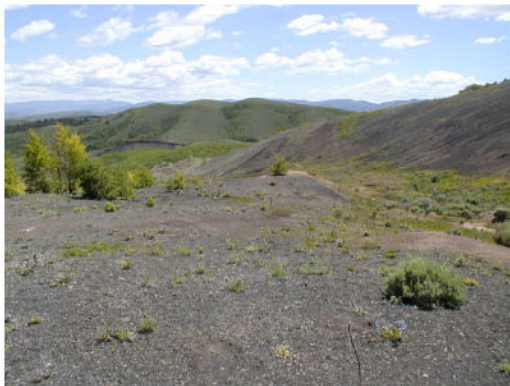
15

The fifth and final area of MWD082 that is not well reclaimed is the portion of the waste rock dump that is located E of MMP040. The top and side slopes of this area appears to have mostly sparse to moderate vegetation growth (PR02). Note, there is a large area of bushes and shrubs growing on a portion of the top of this area. See Photo 15.

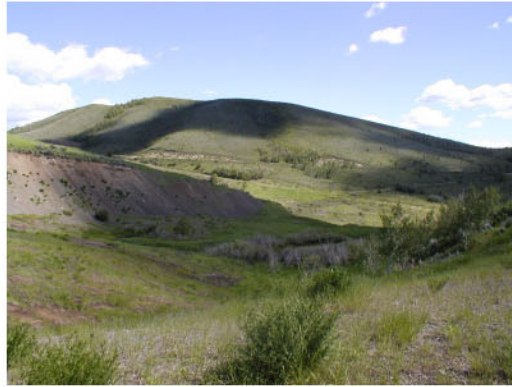
- MMP040: Located in the east-central portion of Ballard Mine. The MMP040 area is a small pit located S of MMP039 and W of PR02. The pit and backfilled areas of the pit appear to have no vegetation to sparse vegetation growth (UR05). Some sparse alfalfa growth was observed in this area, especially on low areas and terraces. See Photos 16 and 17. Further up the road through MMP040 is another area that appears to be the N end of MMP036 and is discussed below. See Photo 18.

- MMP036: Located in the central portion of Ballard Mine. The pit, backfilled, and disturbed areas appeared to have no vegetation to sparse vegetation growth in most areas (UR06). See Photos 18 and 19.

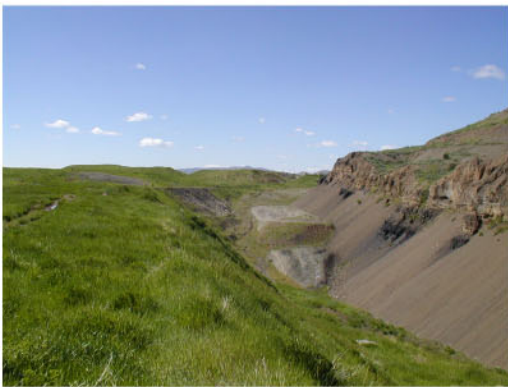
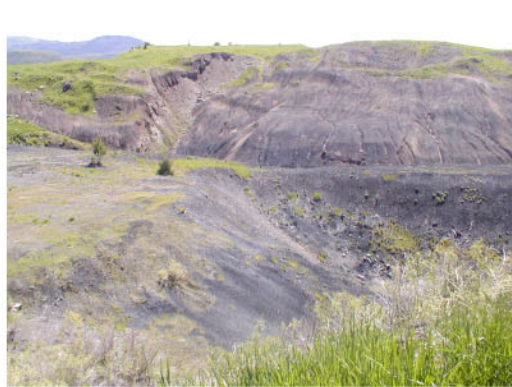
- MWD093: Located in the central portion of Ballard Mine, W and NW of MMP036. This waste rock dump appears to be backfilled or placed in a mine pit, possibly part of MMP036 mine pit. The lower and upper elk ponds appear to be located on waste rock/mining areas of MWD093 or MMP036. The main portion of the waste rock dump N and NW of the elk ponds appears to be moderately vegetated with grass and alfalfa (PR03). Photo 20. Some areas, especially the areas surrounding the elk ponds and side slopes, appear to have no vegetation to sparse vegetation (UR07). See Photos 21 and 22.

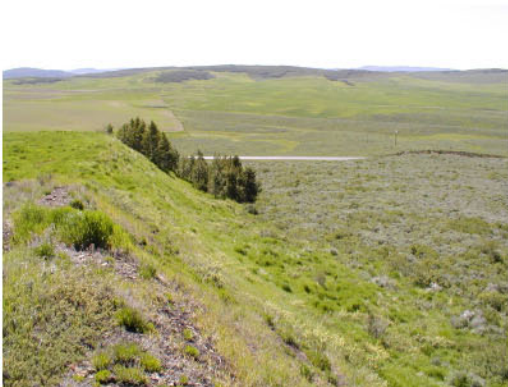
23

- Unmapped Waste Rock Dump: Located E of MMP035, also N, NE, and E of MSG003 (Garden Hose Spring), and W of MWD093 the waste rock dump. This waste rock dump does not appear to be mapped on the Figure 2-1. This dump may be part of MWD093, but it may be just incorrectly mapped. Overall, the waste rock dump appears to moderately to densely vegetated (WR03), especially on the top of the waste rock dump, while the side slopes appear to be moderately vegetated (PR04). See Photo 23.

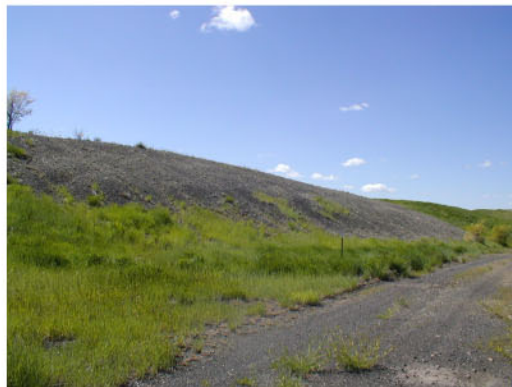
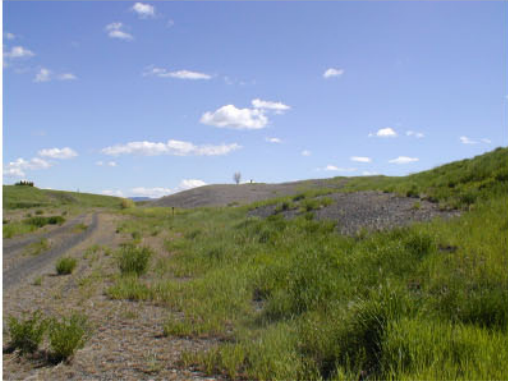
- MMP035: Located in the W portion of Ballard Mine. The pit area and backfilled areas appear to have no vegetation to very sparse vegetation (UR08). See Photos 24 and 25.

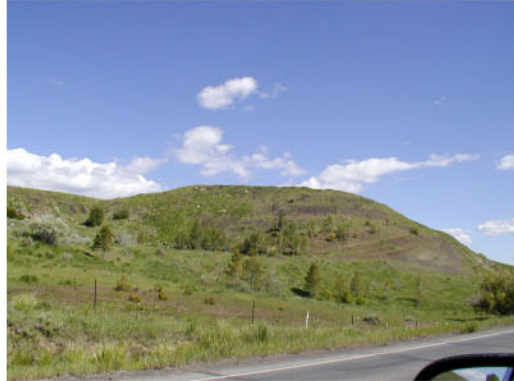
26

- MWD080: Located in the NW and W portion of Ballard Mine. All of the MWD080 waste rock dump, except four localized areas, appear to be well vegetated (moderately to densely) with mostly grasses (less alfalfa than other areas of Ballard Mine) and the experimental reclamation planted trees and shrubs (WR04). See Photo 26.

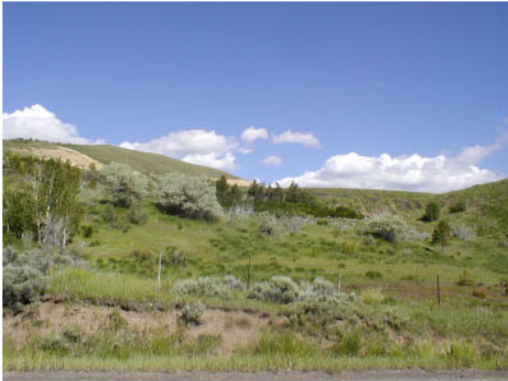
27

The first area of MWD080 that is not well reclaimed is located at the S end of MWD080, just N to NW of the Ballard Mine shop building. The area is on the north (left) side of the gravel road leading to the mine pit (MMP035). The area appeared to have no vegetation to very sparse vegetation (UR09) and the soils consisted of black, tan, and white shales. See Photo 27.

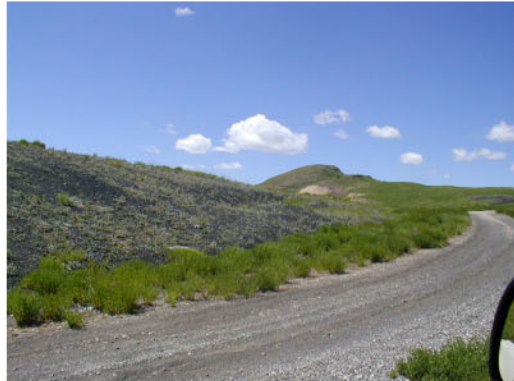
28

The second area of MWD080 that is not well reclaimed is located N of UR08. From UR08, the gravel road splits to the N and S. Taking the road to the N, the area is located on the west side of the gravel road. The small area appears to have almost no vegetation (UR10) and the soil consists mainly of black and tan shales. See Photo 28.

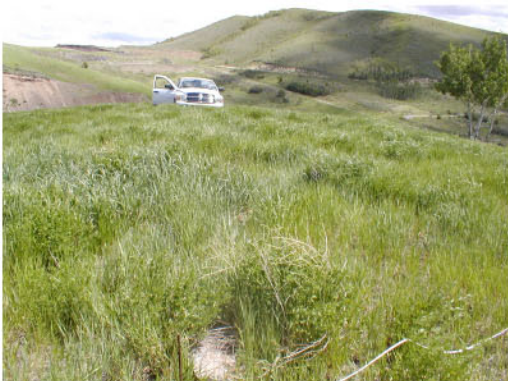
29

The third and fourth areas of MWD080 that are not well reclaimed are located on the west slope of the waste rock dump along the haul road. One area of sparse to moderate vegetation (PR05) is located on the west slope of the waste rock dump S of the dredge pond. See Photo 29. The other area of sparse to moderate vegetation (PR06) is located on the west slope of the waste rock dump N of the dredge pond. See Photo 30.
